CAPTAIN FLAT GROUNDWATER MONITORING CAPTAINS FLAT, NSW

Project name **Captains Flat Groundwater Monitoring**
Project no. **318001193-T27-01**
Recipient **Department of Regional NSW**
Document type **Report**
Version **Rev 1 Final**
Date **09/12/2022**
Prepared by **Stephen Maxwell CEnvP SC 41184**

Description **This report describes the methodology and factual results for two six-monthly groundwater monitoring rounds undertaken as part of the Captains Flat Lead Management Plan at Captains Flat, NSW.**

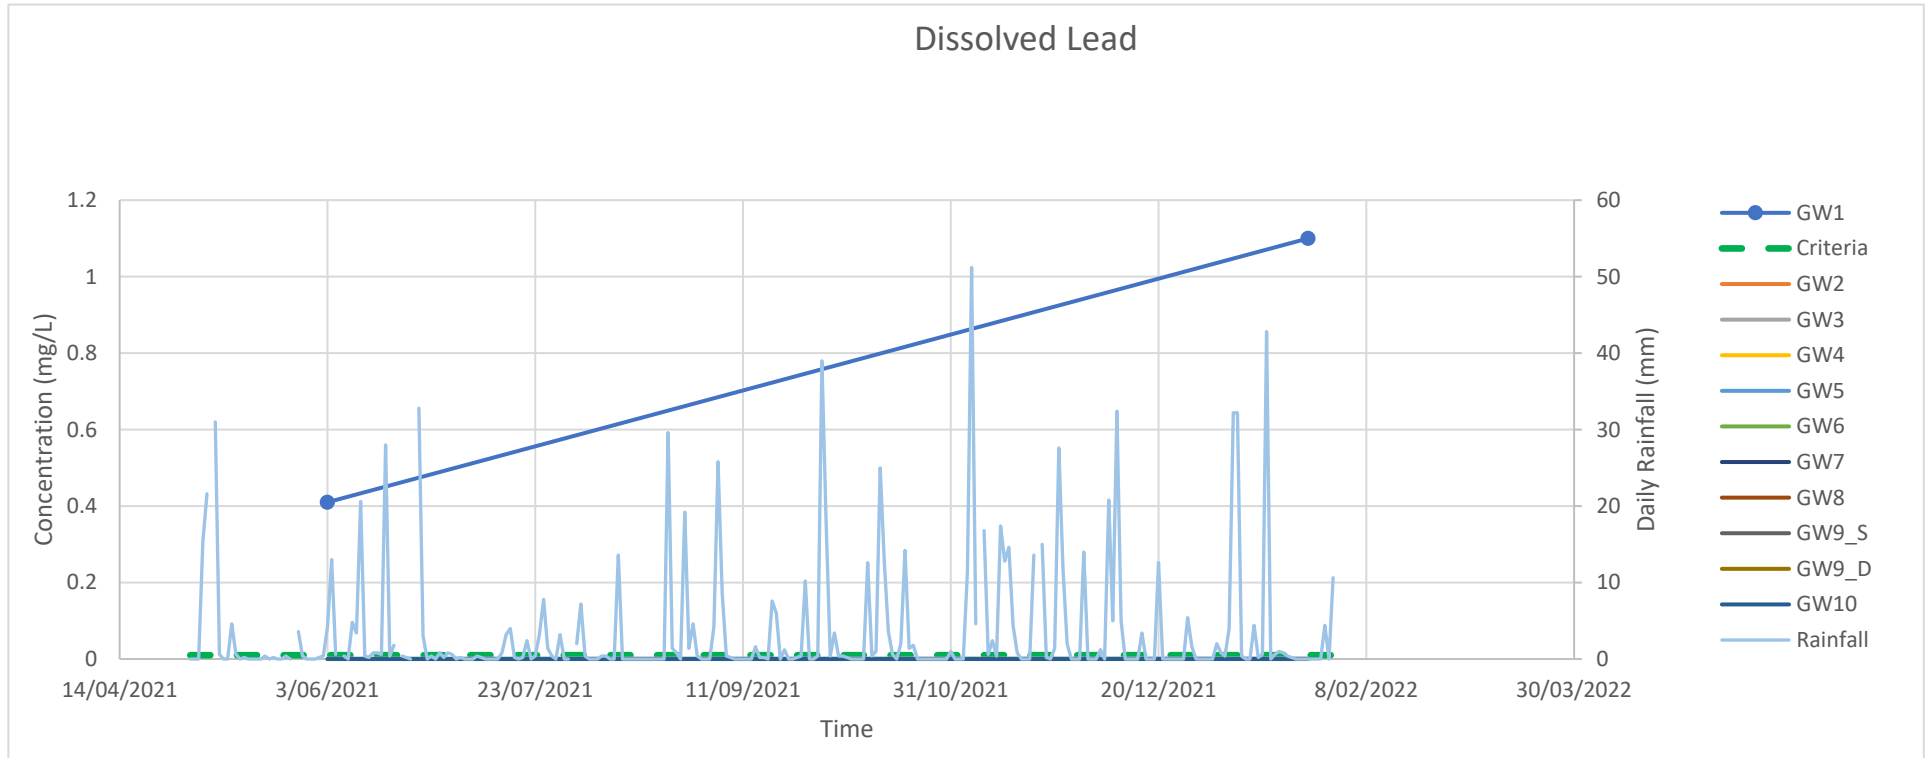
Figure 5.1: Dissolved Lead Concentration Trend

Concentrations of heavy metals that exceeded the Australian Drinking Water Guidelines (ADWG) criteria in groundwater were assessed for temporal trends. Concentrations were generally similar or decreased slightly from June 2021 to January 2022, with the exception of cadmium, lead and zinc at location GW1. The cause of localised increases in cadmium, lead and zinc at GW1 (adjacent the former Captains Flat Preschool) is unclear although it may be due to sustained periods of above average rainfall that were observed in the Precinct in January 2022.

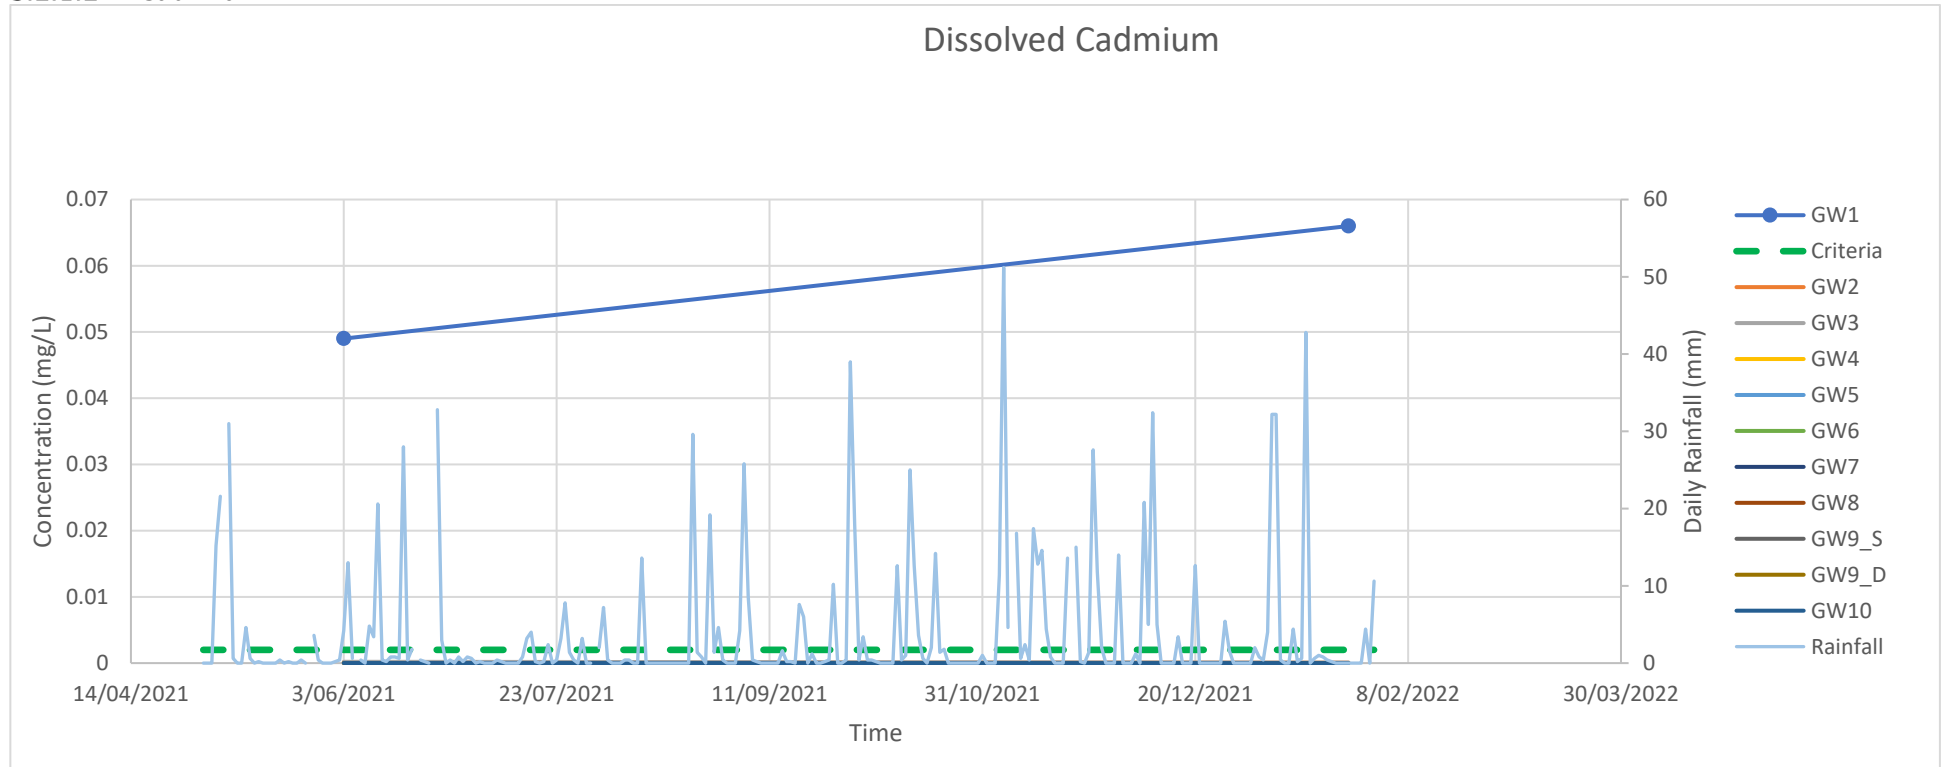
Figure 5.2: Dissolved Cadmium Concentration Trend

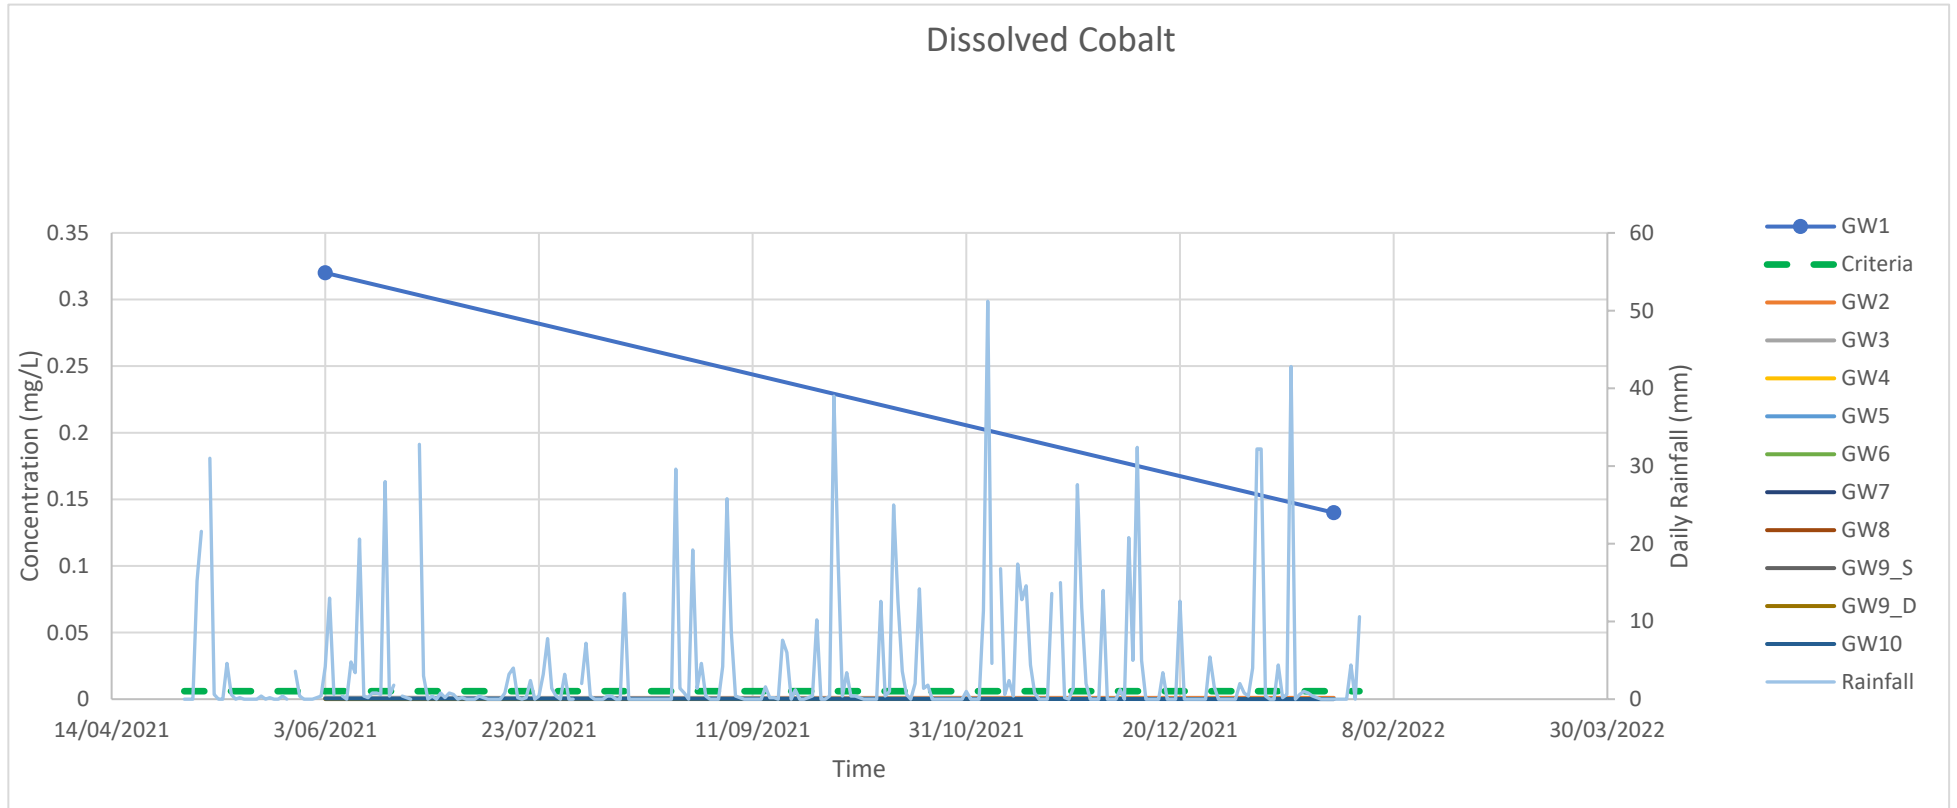
Figure 5.3: Dissolved Cobalt Concentration Trend

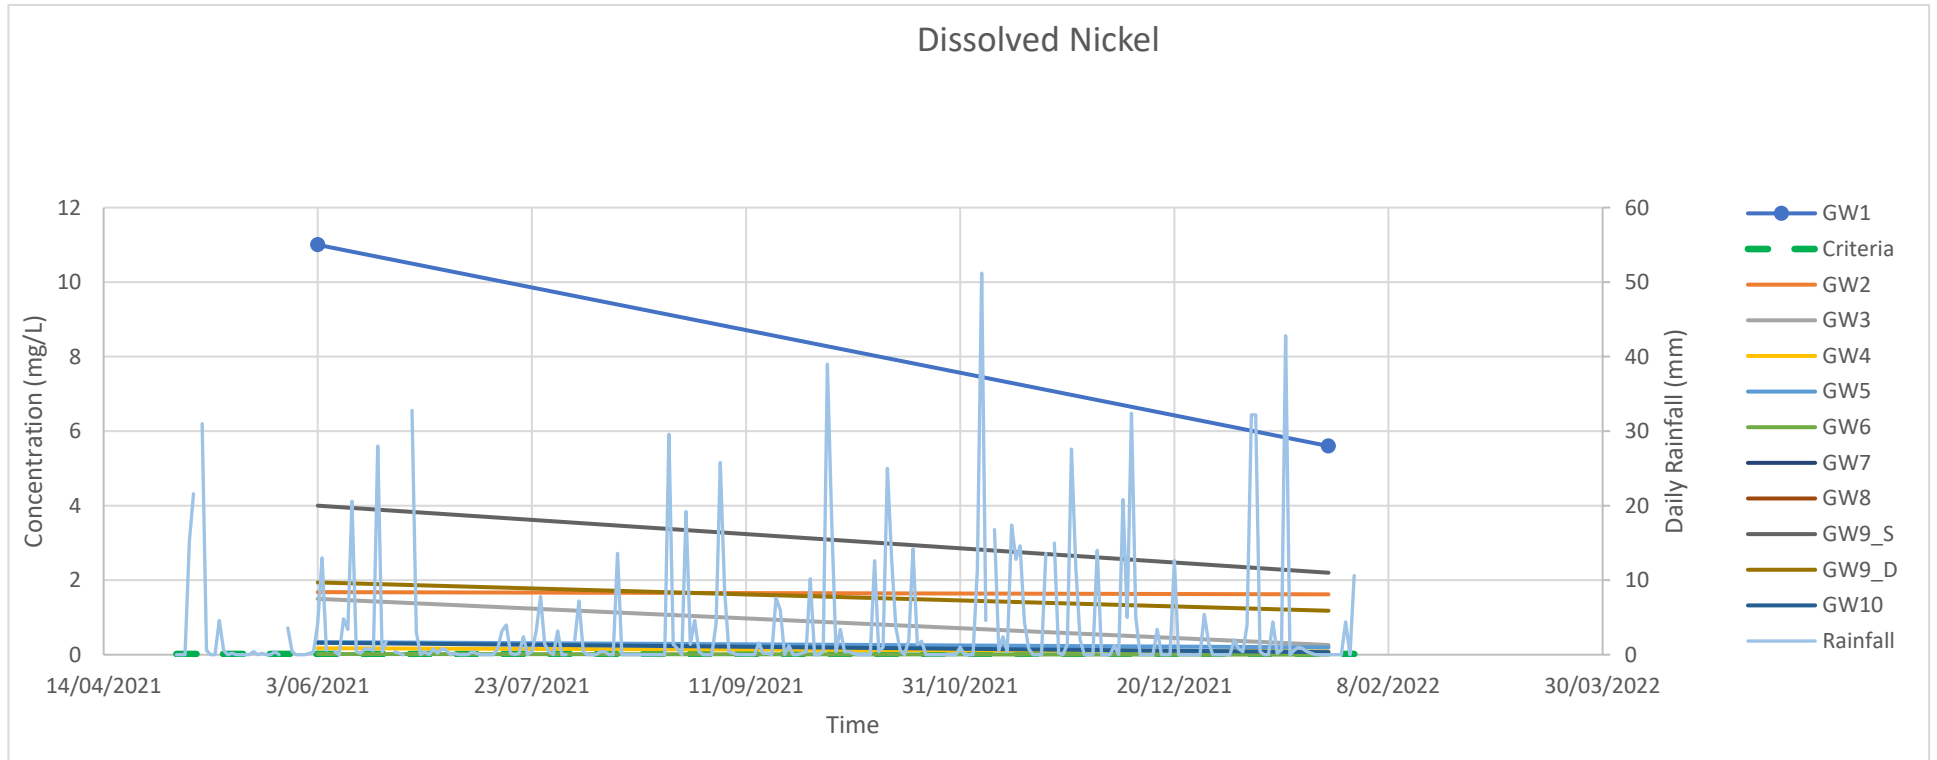
Figure 5.4: Dissolved Nickel Concentration Trend

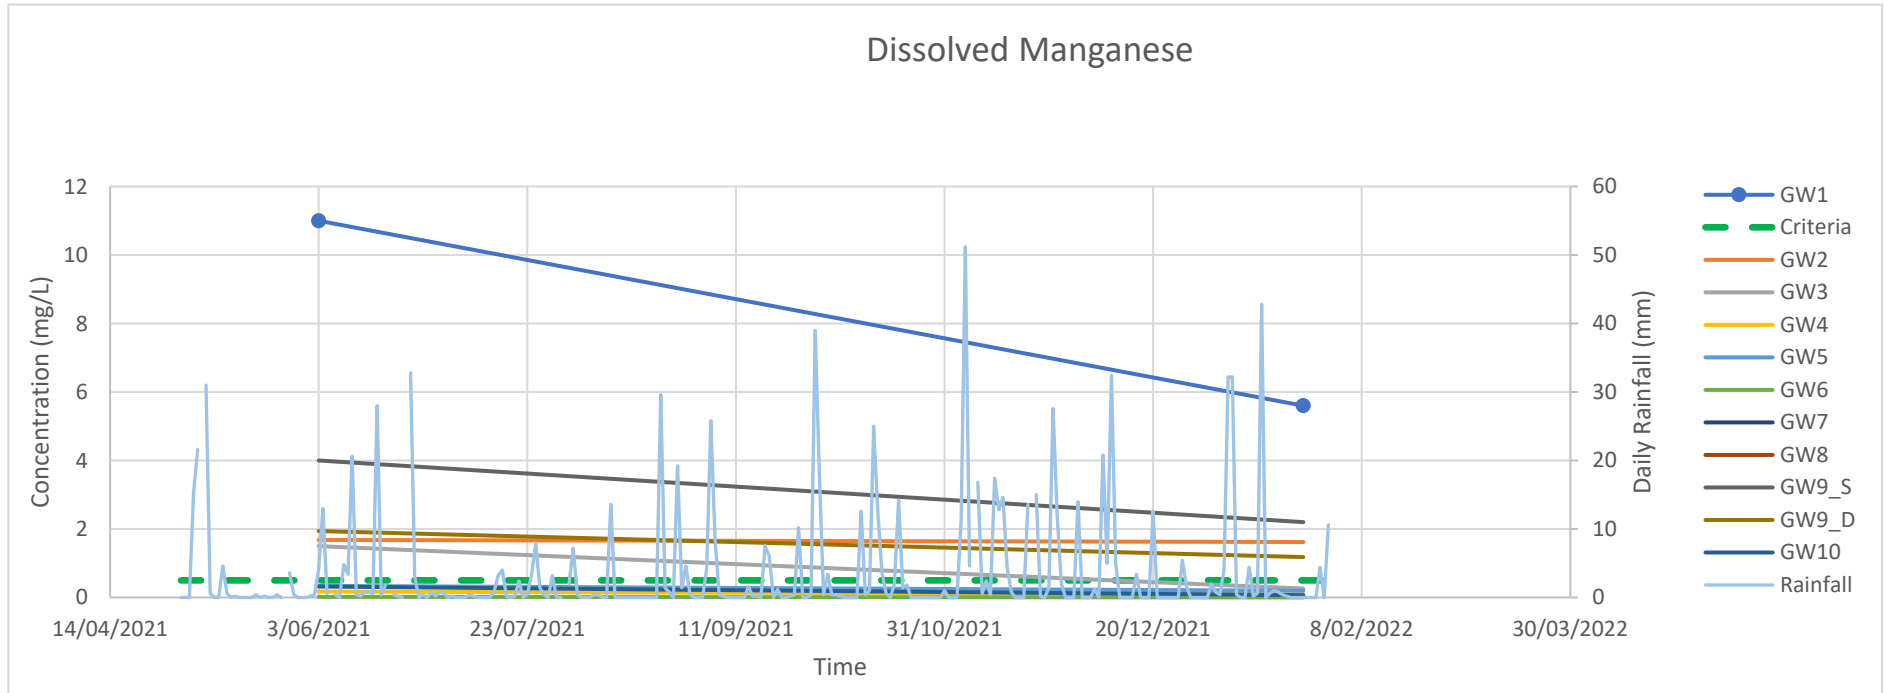
Figure 5.5: Dissolved Manganese Concentration Trend

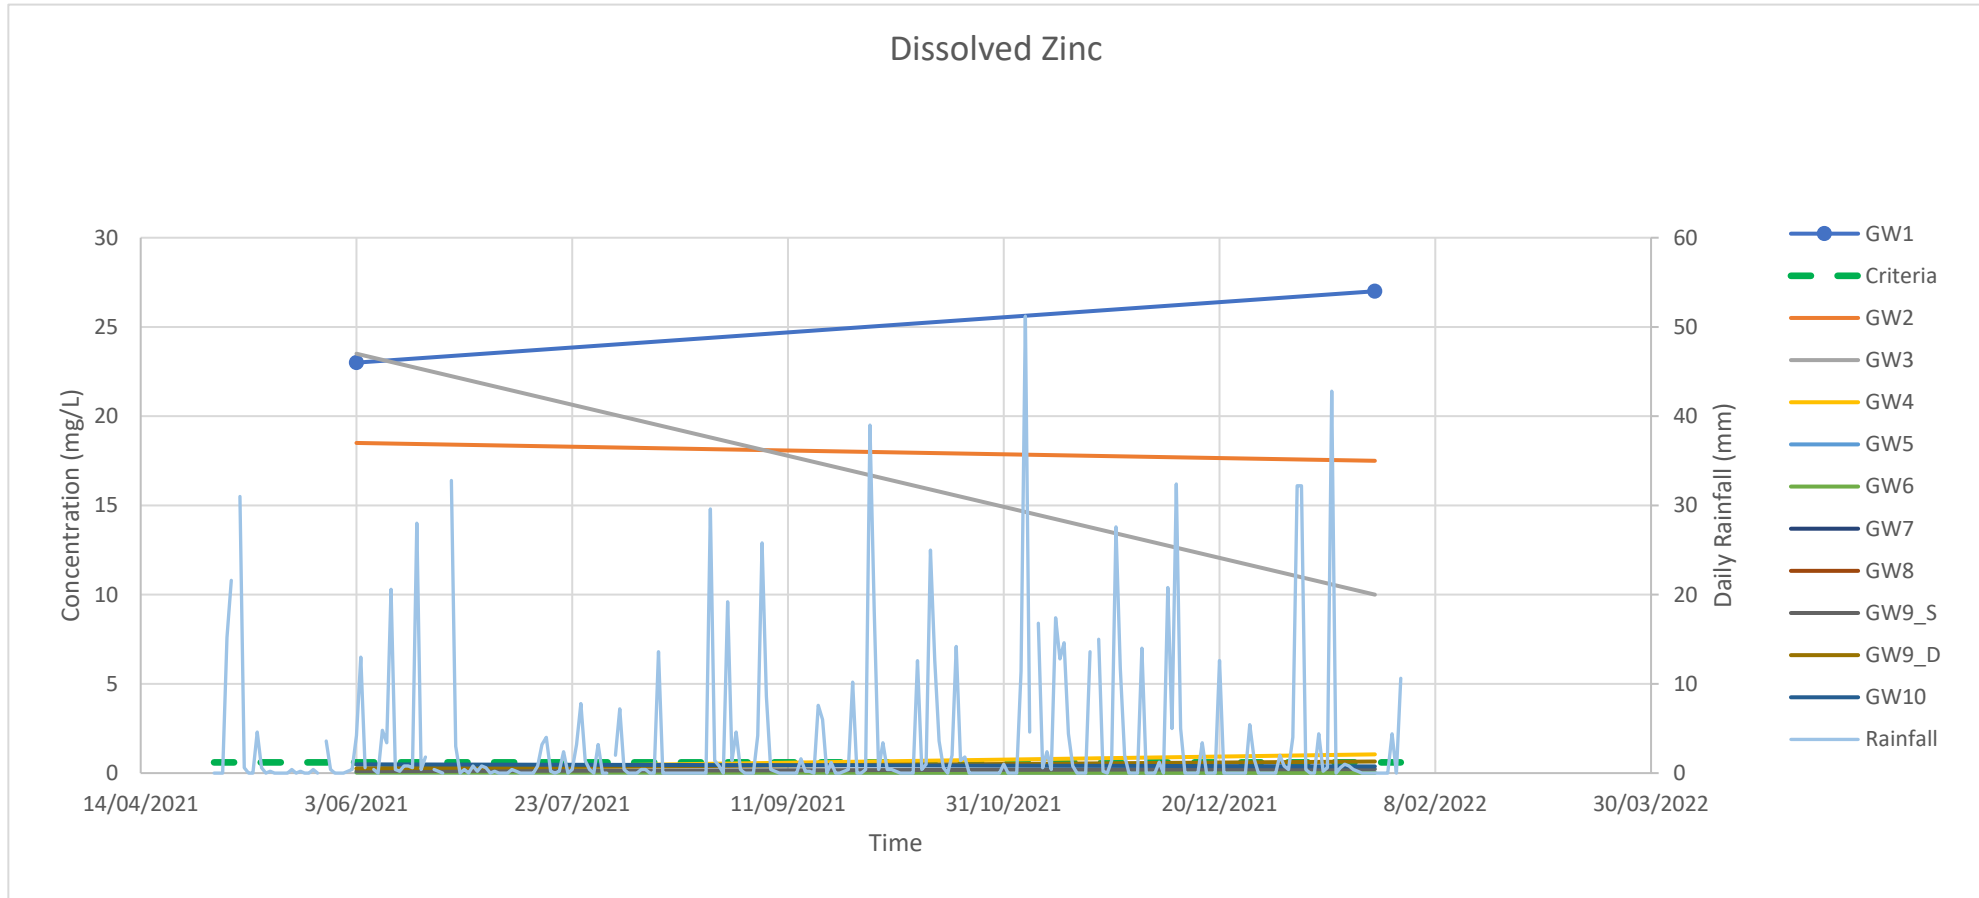
Figure 5.6: Dissolved Zinc Concentration Trend

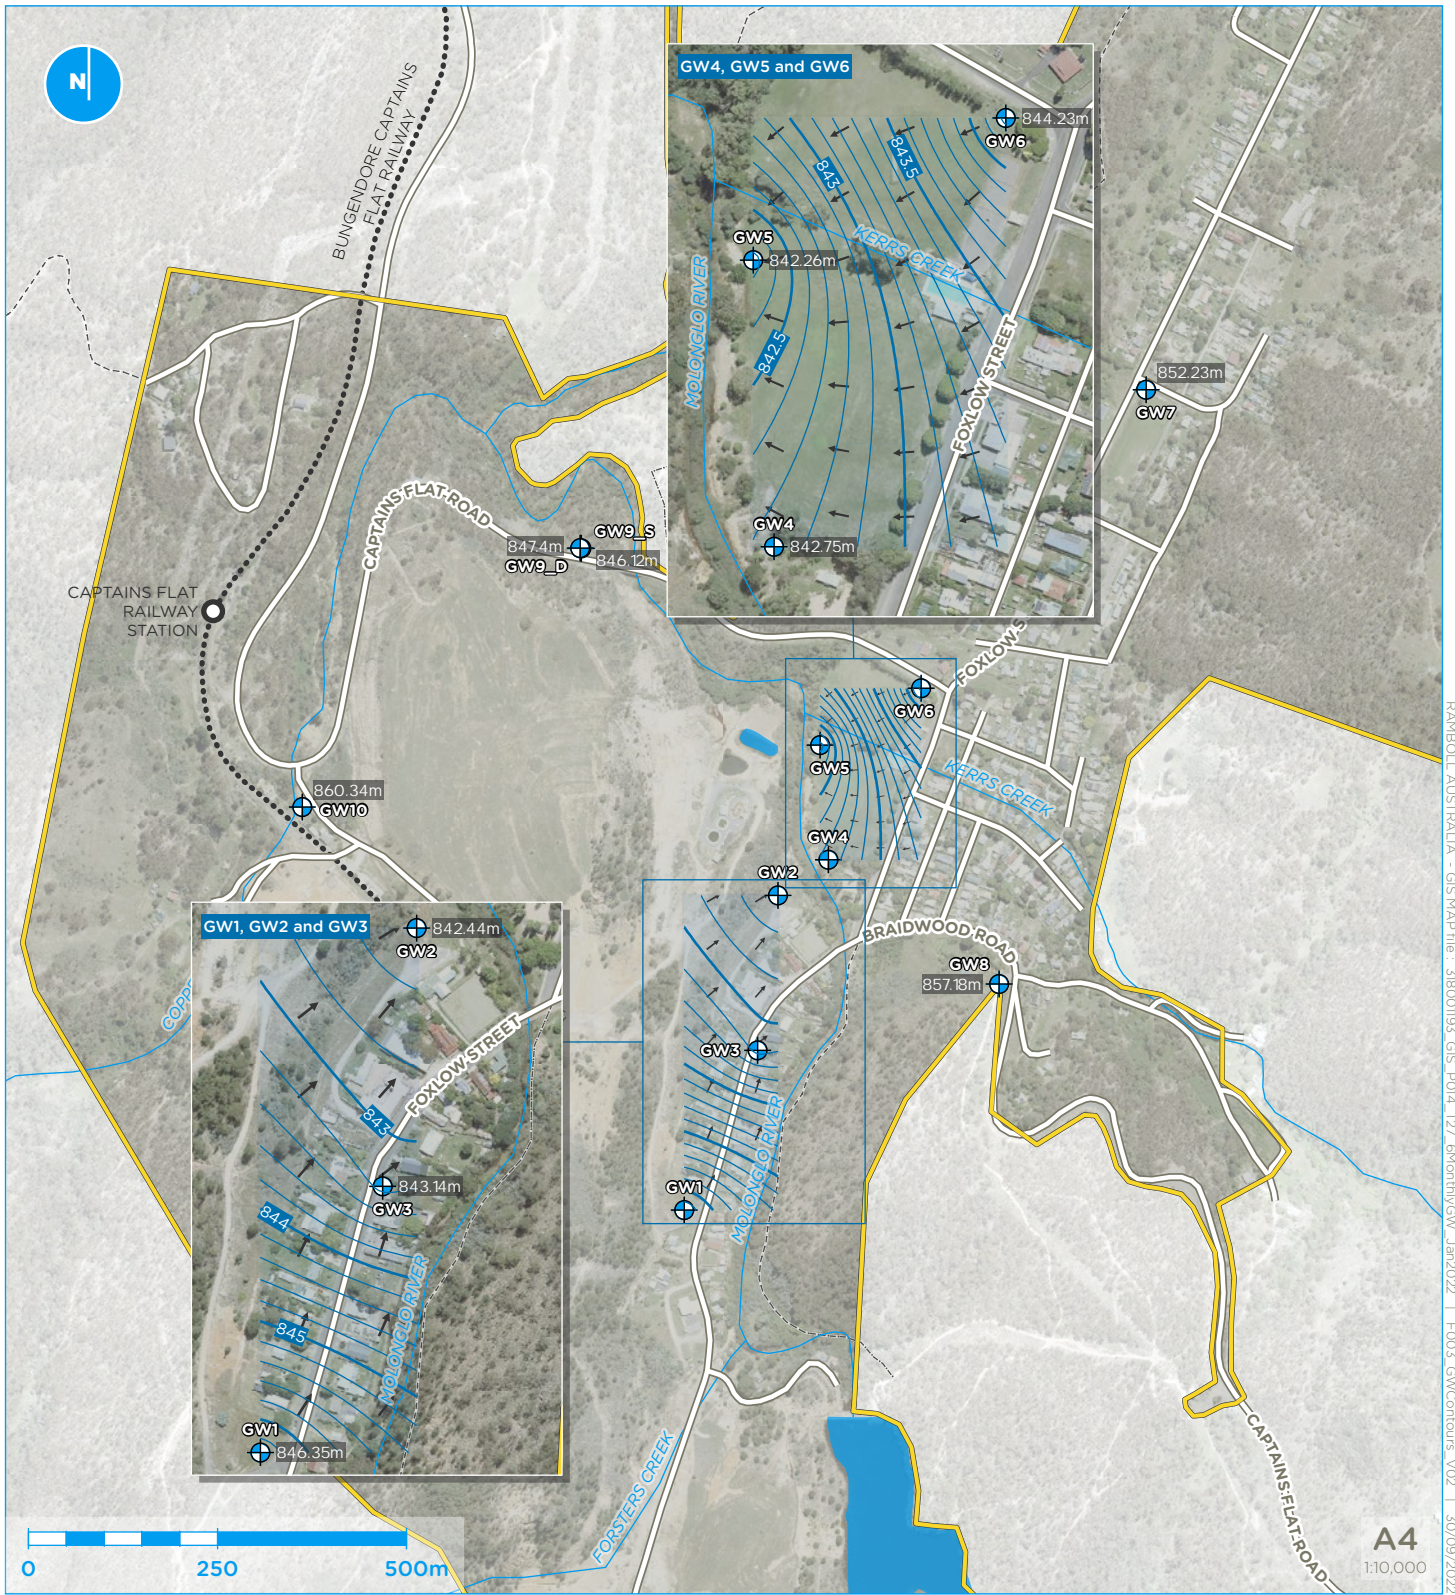
Figure 3 : Groundwater contours - January 2022
Captains Flat Groundwater Monitoring

Figure 3, Appendix 1 presents groundwater contours based on the standing water levels. Groundwater flow direction interpreted as perpendicular to contour lines is inferred towards Molonglo River. This flow direction generally correlates with expected groundwater flow conditions based on the topography of the surrounding area.

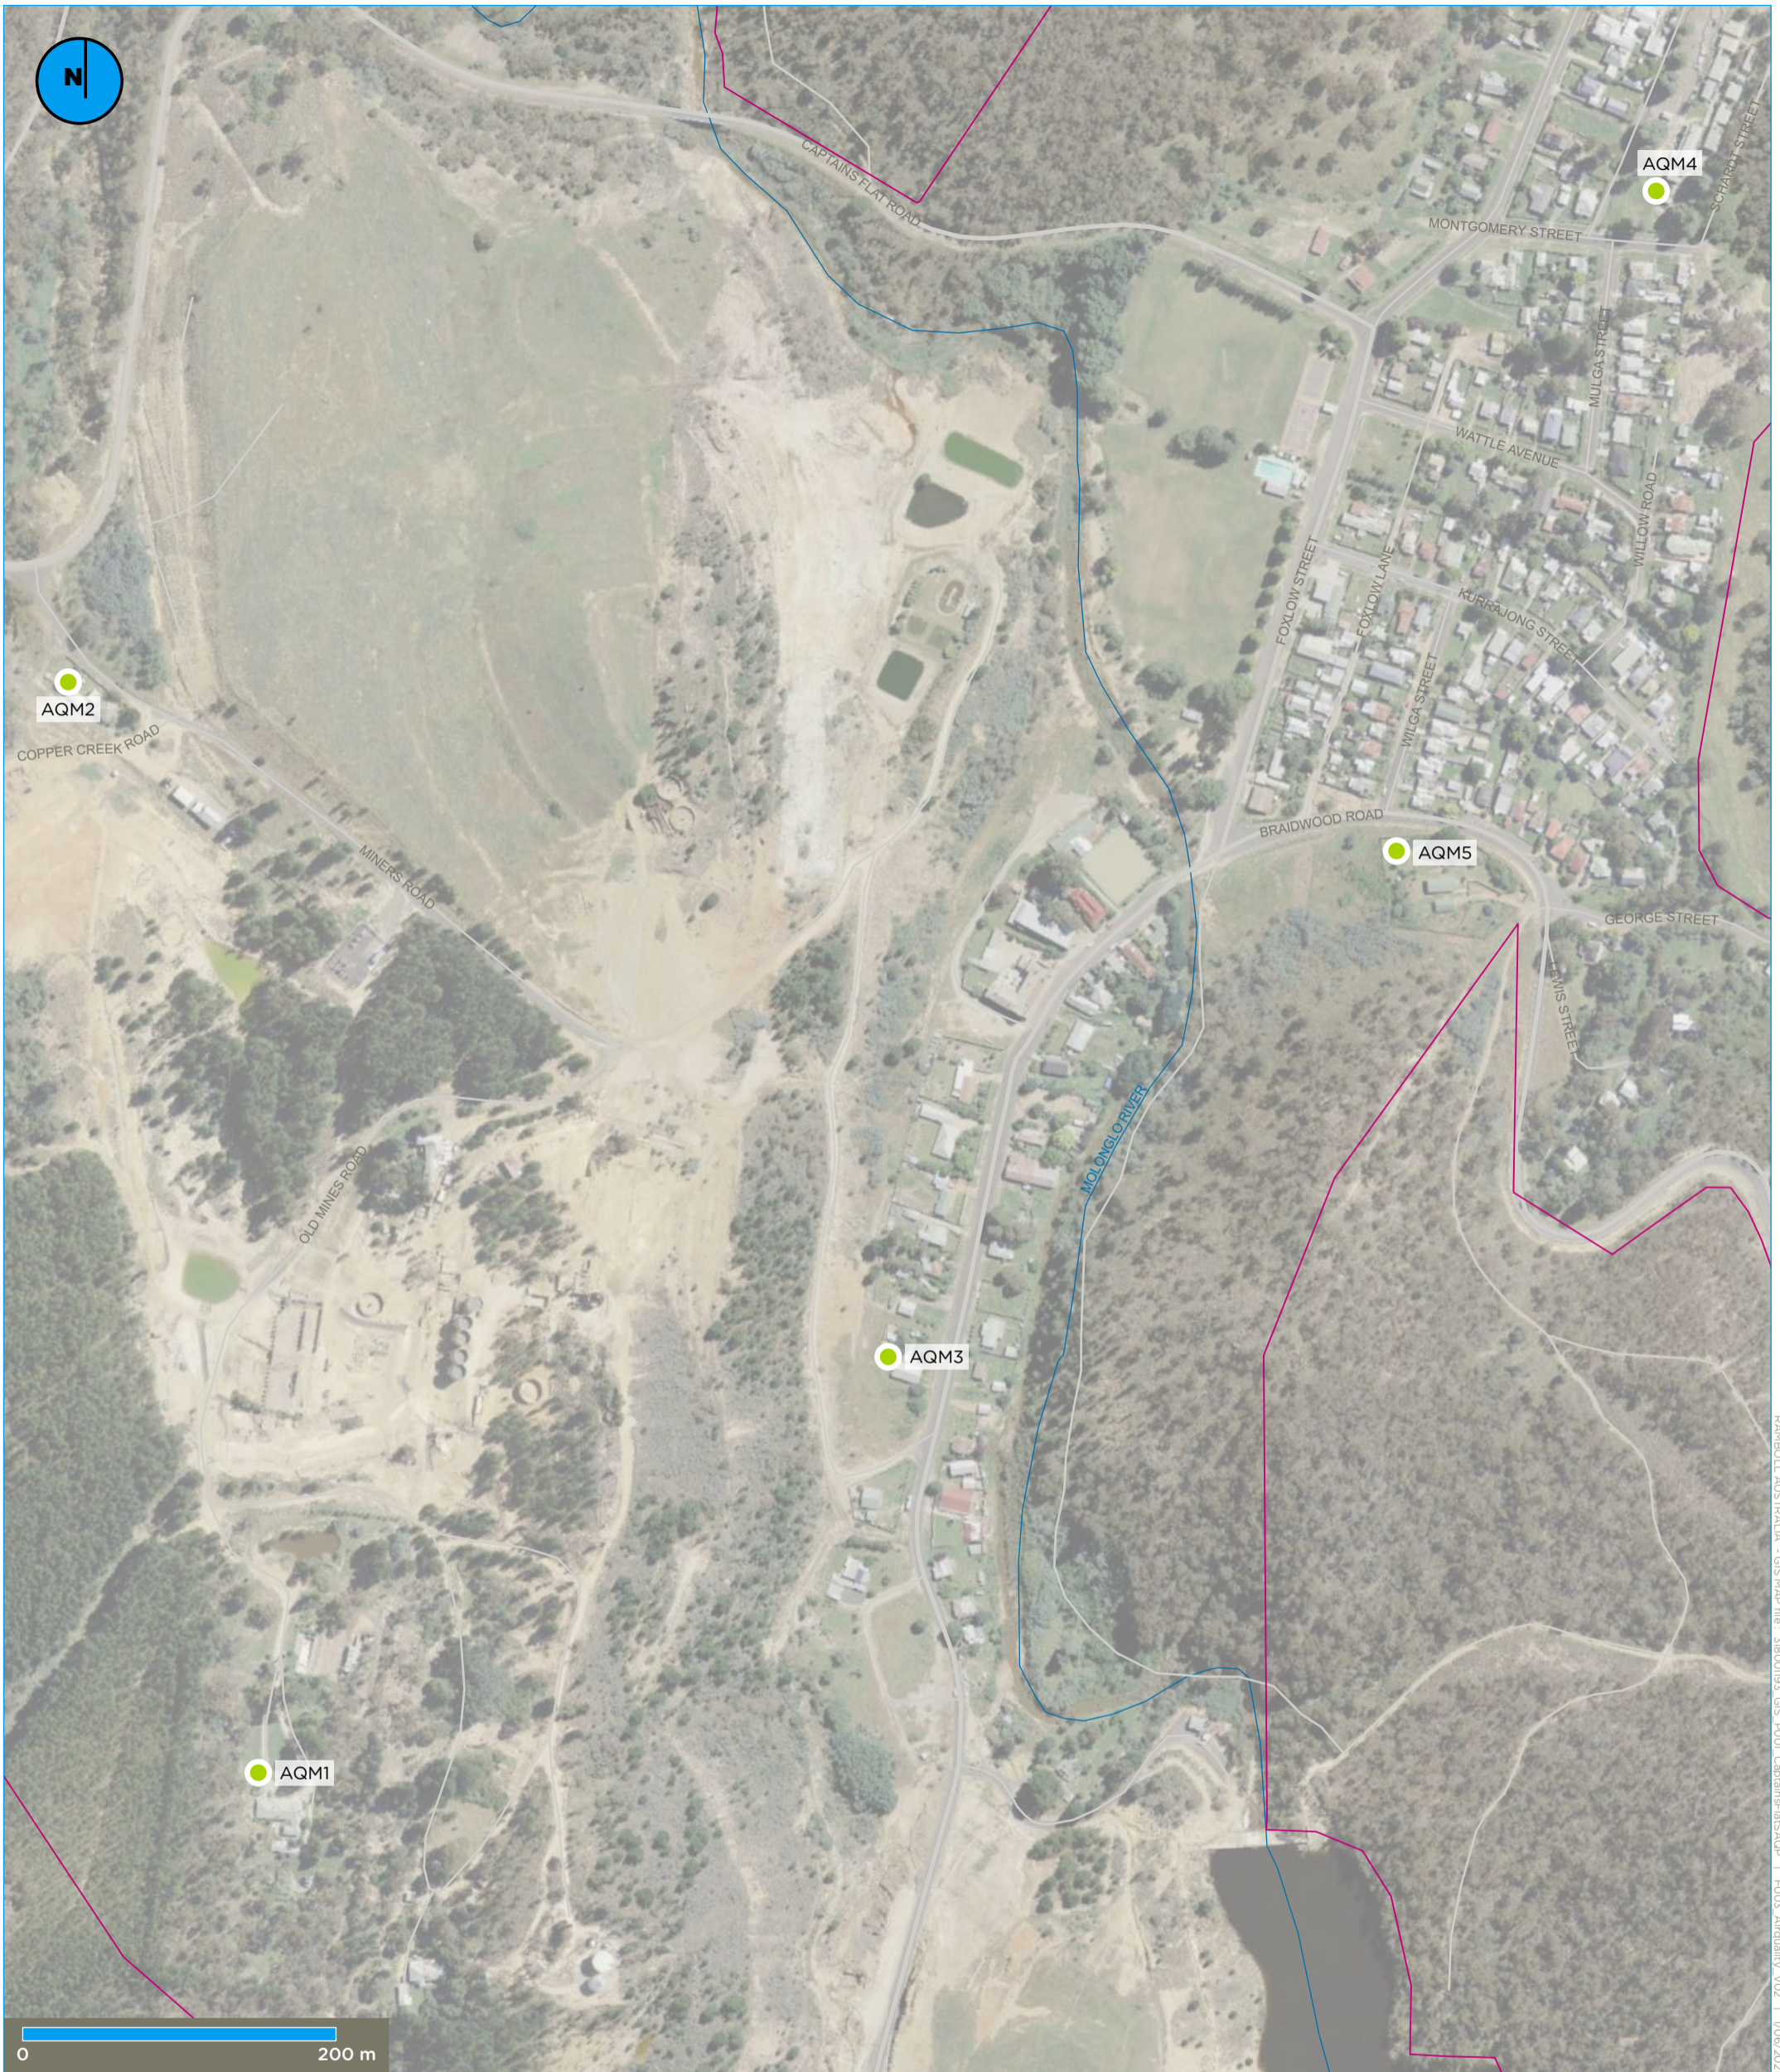
Figure 3 : Air quality monitoring locations

Five locations in Captains Flat are proposed for monitoring heavy metals in airborne particulate matter. The five proposed monitoring locations are summarised in Table 7-4. The air quality criteria are relevant at sensitive receptors, so it is preferable to monitor in community locations such as residences and schools rather than industrial locations such as the sewage treatment plant or SES. Should measurement of meteorological conditions be further considered for this location, it is recommended that equipment be located at AQM4 given the elevated terrain in this location which would be representative of prevailing regional conditions.

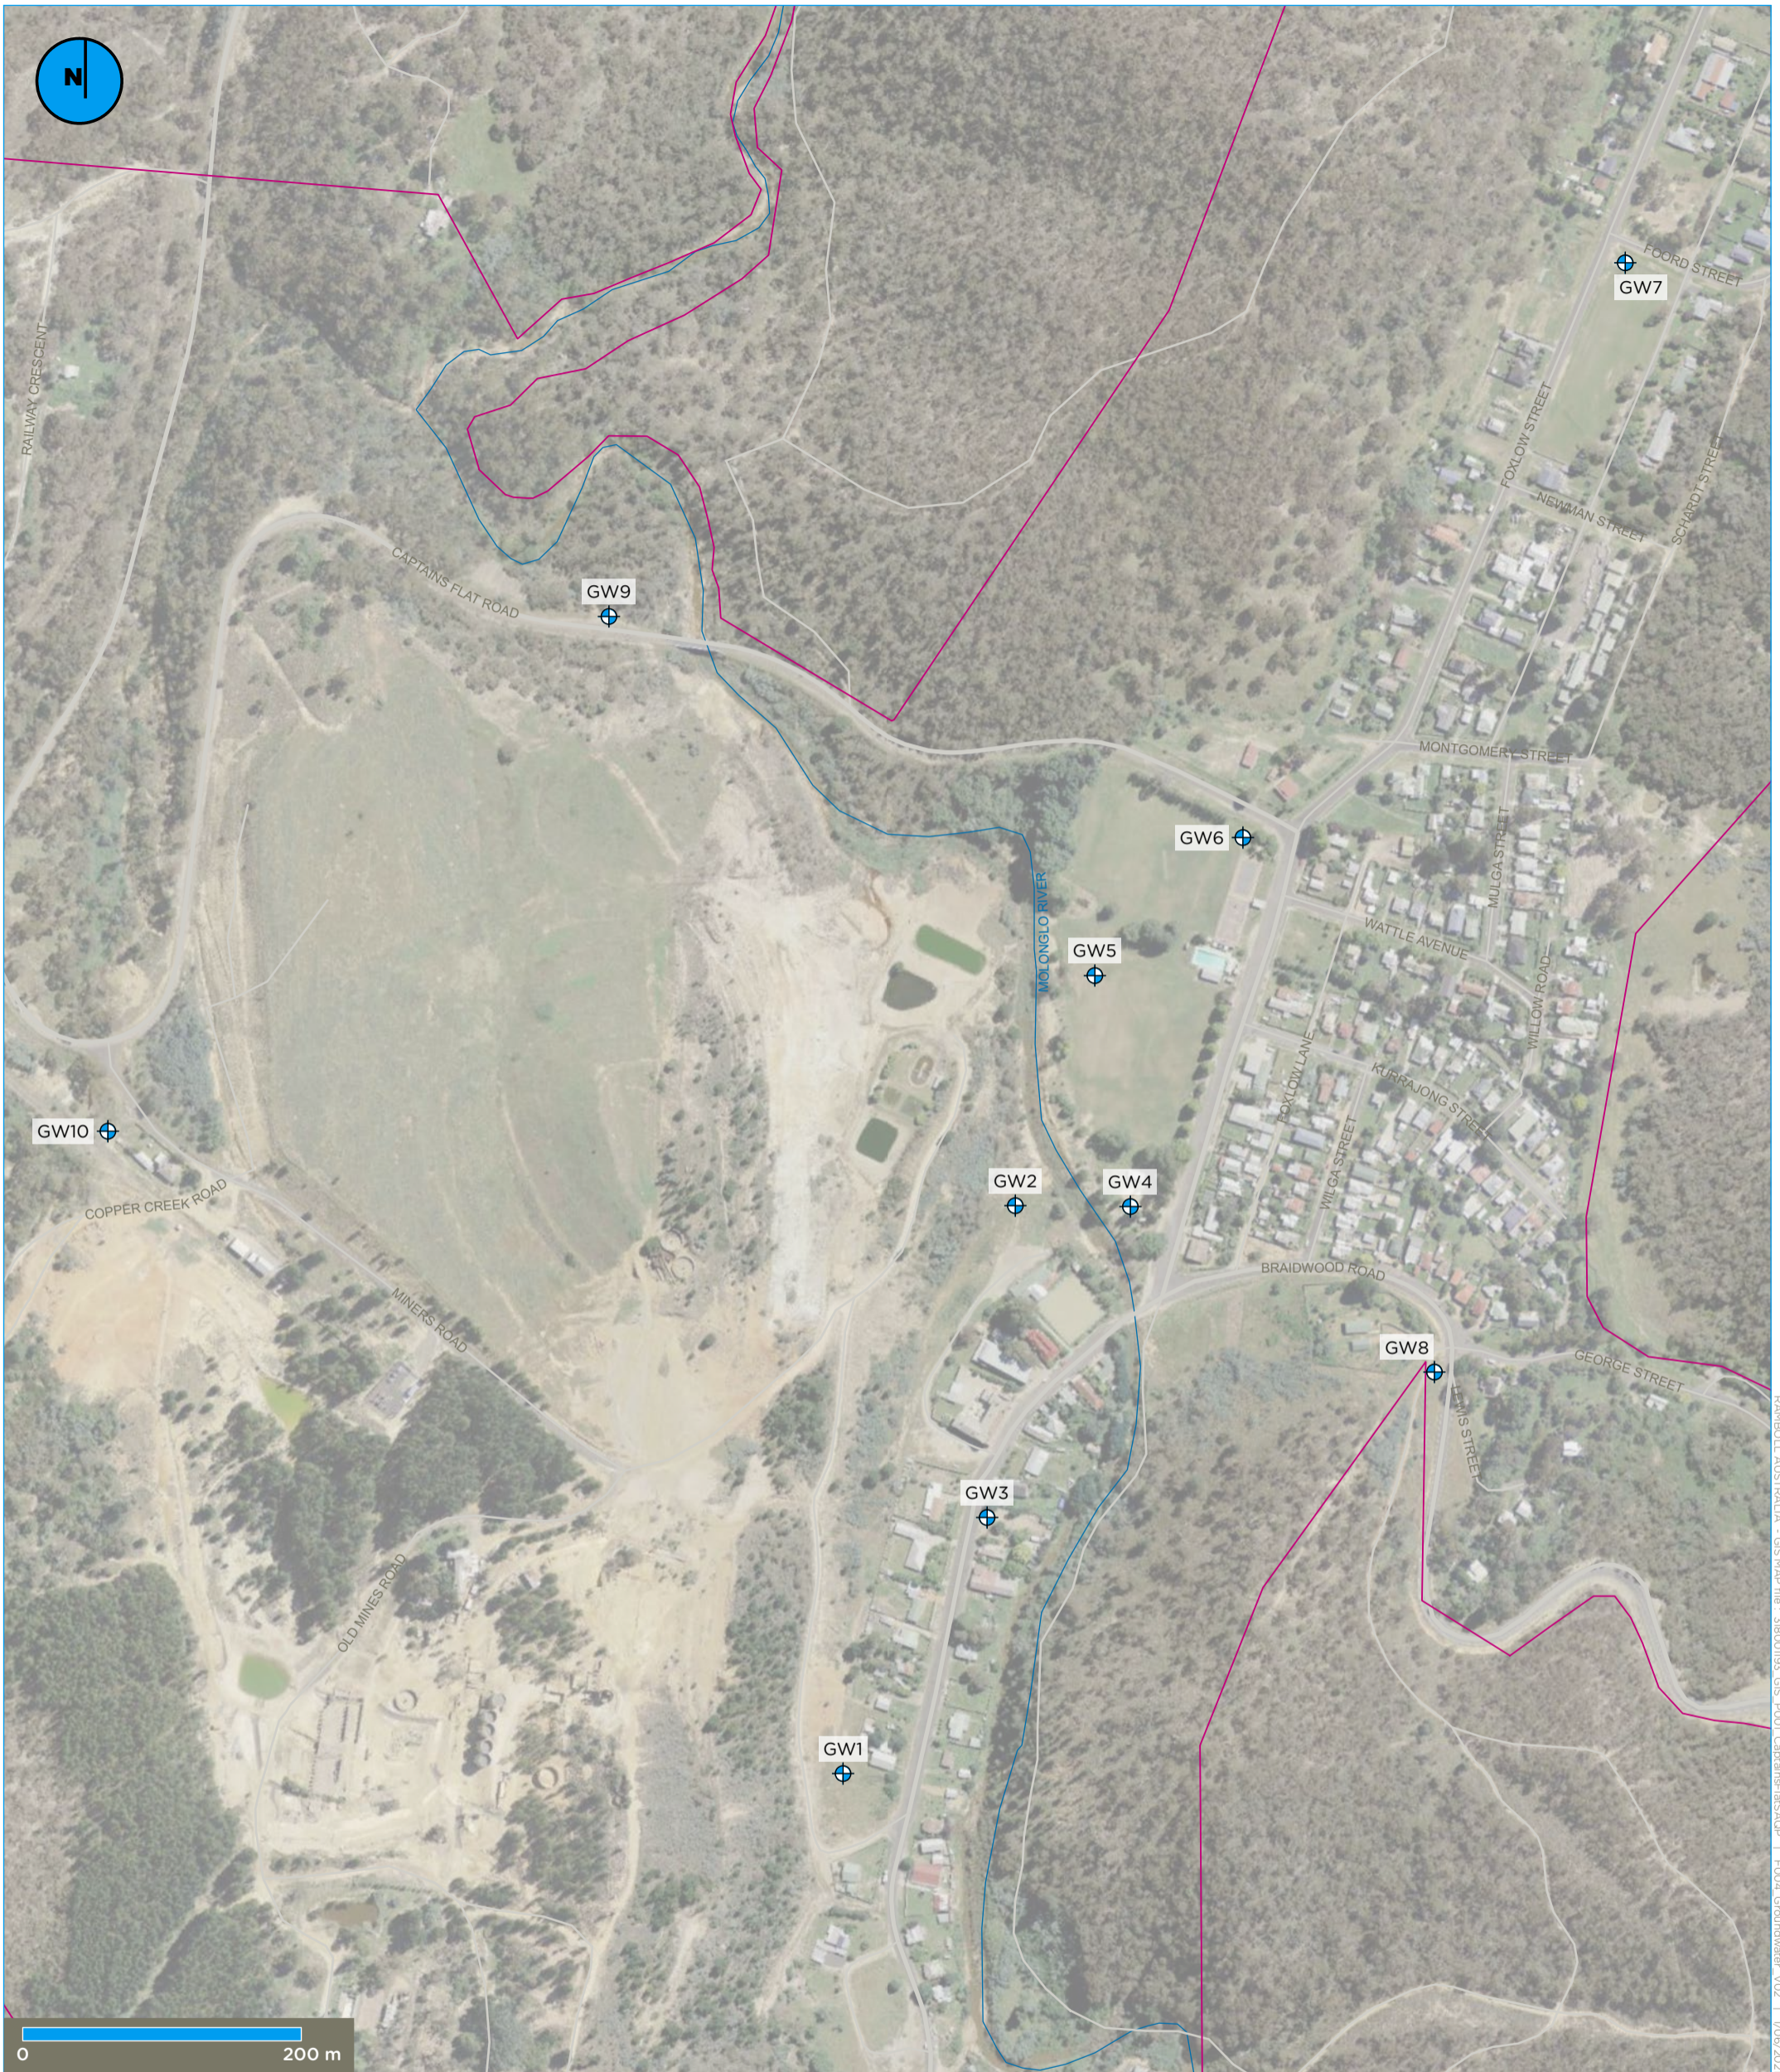
Figure 4 : Groundwater monitoring locations
